# Heineken PV facility

Reference: GPEMF/19-20/0054

## Operational Environmental Management Audit Report

**Prepared by: Barbara Raubenheimer**  
**June 2026**

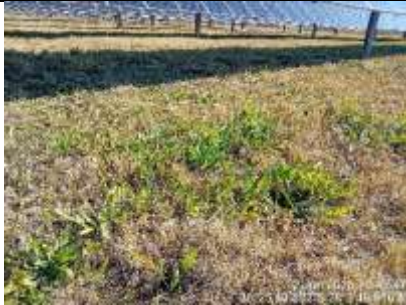
| Image | Example and Action | Timeframe to Resolve |
|---|---|---|
| | Example of alien plant vegetation occurring on site between the solar panels, in open areas and other areas on site. | <b>Ongoing- through operational lifespan.</b> |

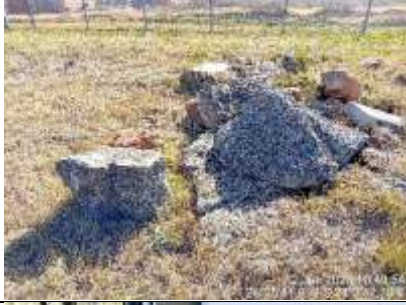
| Image | Example and Action | Timeframe to Resolve |
|---|---|---|
| | Example of building rubble occurring in the open space area adjacent to the solar field. All building rubble is to be removed carefully, not damaging the surrounding rehabilitated areas. | <b>Medium term- Prior to next bi-annual audit.</b> |

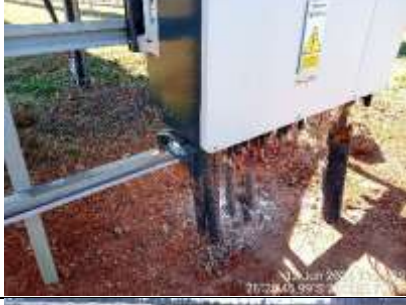
| Image | Example and Action | Timeframe to Resolve |
|---|---|---|
| | White residue (burn shield) from an inverter that caught fire recently (confirmed by an on-site technician). Incident should be recorded and resolved with the burn shield being cleaned. | <b>Short term- Immediate</b> |

To date, no environmental incident has been recorded. It is however noted that a fire of an inverter was not recorded anywhere to the knowledge of the ECO. An incidents register platform is in place, a physical register for complaints and incidents may assist staff to document incidents and complaints.

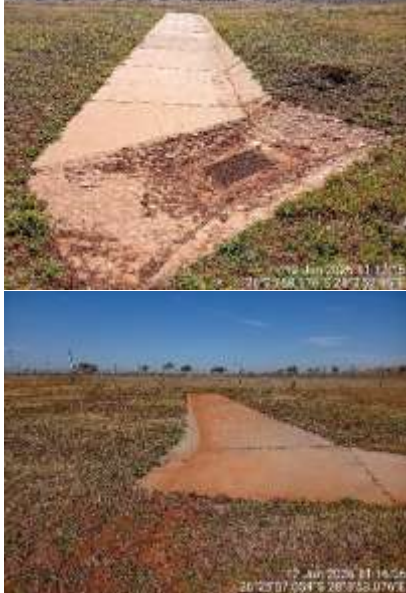
| Image | Example and Action | Timeframe to Resolve |
|---|---|---|
| | Eroded soil that washed into the storm water drain from an internal road. The erosion mitigating measures limiting erosion from the roadways such as adequate shaping and compacting should be maintained. To prevent siltation of the storm water drain. A net can be placed over the grid. | <b>Medium term- Prior to next bi-annual audit.</b> |

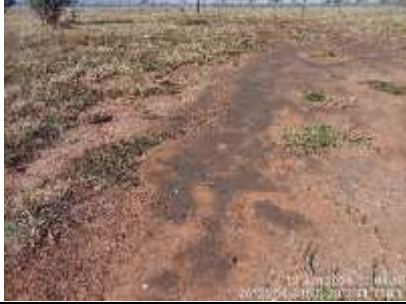
| Image | Example and Action | Timeframe to Resolve |
|---|---|---|
| | Fuel spills occurring on site, internal roads and areas adjacent to the fence from a vehicle that has a leak, likely due to lacking maintenance. Vehicle maintenance is to be conducted regularly, with spills being cleared utilising the on-site spill kit and adequately disposing of the spill kit content.<br><br>All hazardous chemicals on site should also be stored in a hazardous chemical store or an adequate secondary containment area i.e. impermeable surface not prone to run-off. | <b>Short term- Immediate</b> |

| Impact Management Actions | Compliance Results | |
|---|---|---|
| Vehicles and equipment must be maintained in a road-worthy condition at all times. | ✓/X | As a large volume of spills were observed on the internal roads, all vehicles are clearly not being maintained well. |

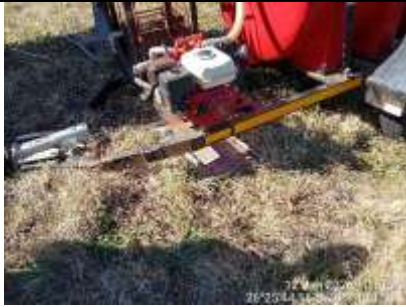
| Image | Example and Action | Timeframe to Resolve |
|---|---|---|
| | The generator utilised for the panel washing on the day of the audit, did not have an adequate drip tray. A sign from site or elsewhere with holes was placed below the generator. Machinery must always be operated with the use of a drip tray to limit and mitigate spills. | <b>Short term- Immediate</b> |

| Impact Management Actions | Compliance Results | |
|---|---|---|
| Care must be taken to ensure that spillage of oils and other hazardous substances are limited during maintenance. Handling of these materials should take place within an appropriately sealed and banded area. Should any accidental spillage take place, it must be cleaned up according to specified standards regarding bioremediation. | ✓/X | A high volume of spills from a vehicle often travelling on site confirms that spills are not being dealt with adequately. The generator utilised for panel washing did not have a drip tray underneath as panel washing was being conducted. |

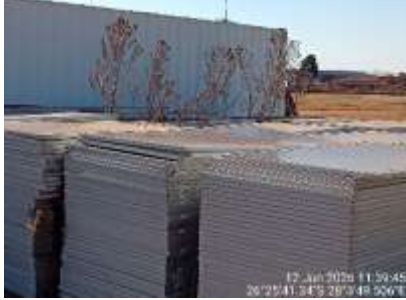
| Image | Example and Action | Timeframe to Resolve |
|---|---|---|
| | Remnant solar panels not adequately removed, stored or disposed of. Solar panel if damaged or unused should be stored adequately (covered) or disposed of at a licensed facility to handle that specific waste stream. | <b>Medium term- Prior to next bi-annual audit.</b> |

| Impact Management Actions | Compliance Results | |
|---|---|---|
| All structures and/or components replaced during maintenance activities must be appropriately disposed of at an appropriately licensed waste disposal site or sold to a recycling merchant for recycling. | ✓/X | The safe disposal of additional solar panels is in the process of being negotiated. |

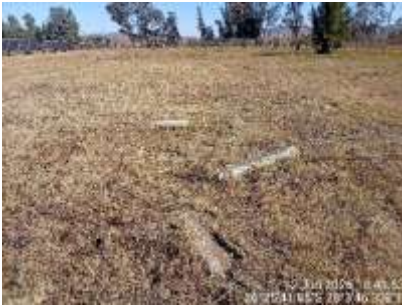
Building rubble on site.

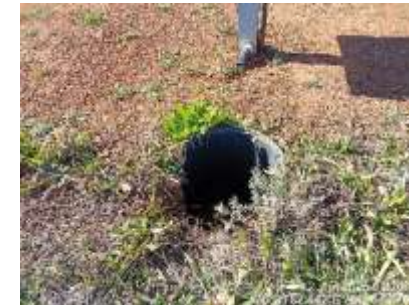
Infrastructure access point damaged.

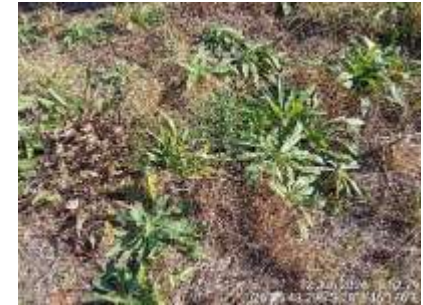
Example of weeds growing on side

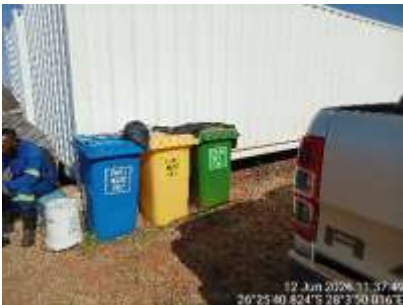
Dedicated labelled waste receptacles

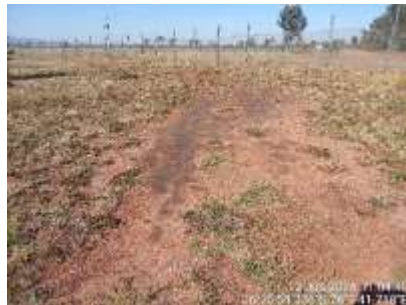
Fuel spills where from leaking vehicle.

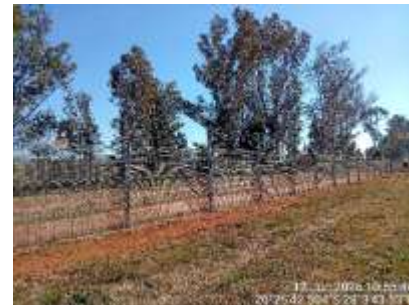
Fence and fire break adequately maintained.

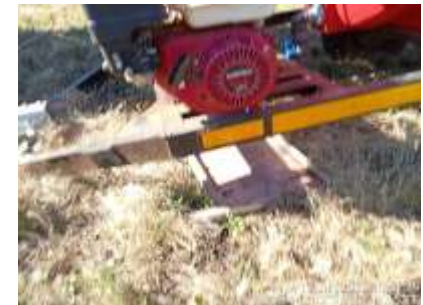
Perforated plate/sign utilised as drip tray.

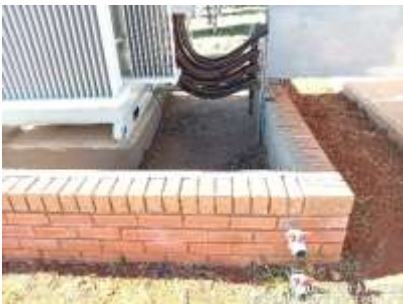
On site tranformer in adequately banded area.

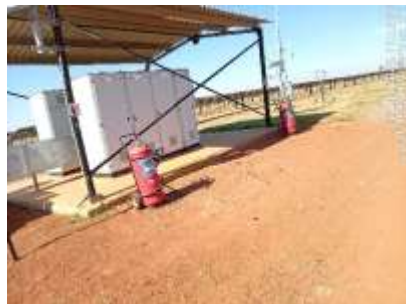
Fire fighting equipment on site.

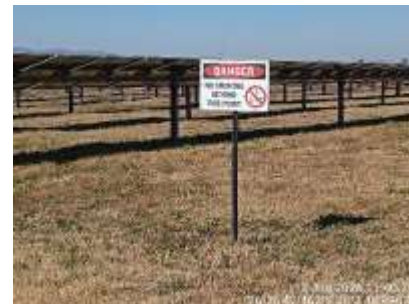
Safety signage, no smoking sign.

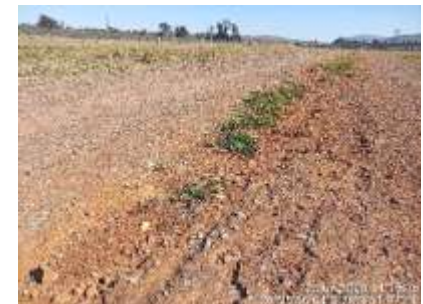
Internal road showing signs of erosion due to run-off.
