# Adams PV facility

EA Reference: 14/12/16/3/3/2/1091 and amendments

## Operational Environmental Management Audit Report

## **Operational Environmental Management Audit Report – June 2026**

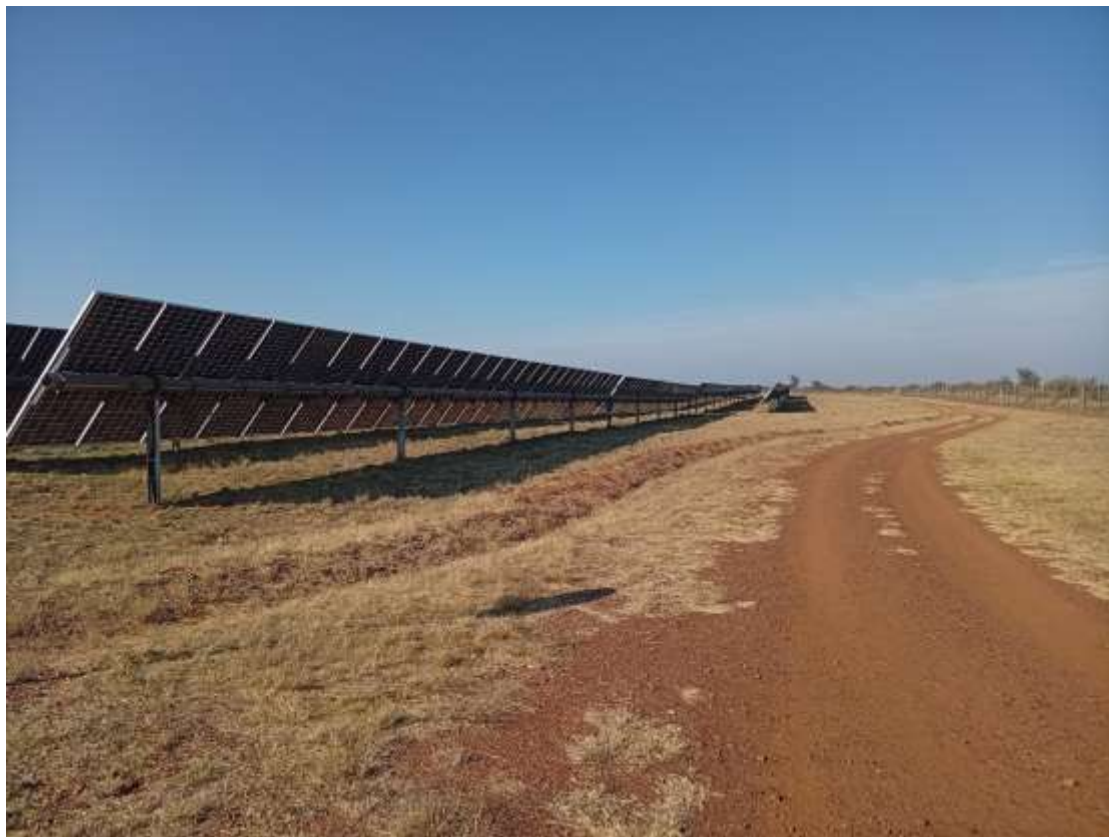
Well vegetated (winter) at Adams PV facility with internal road.

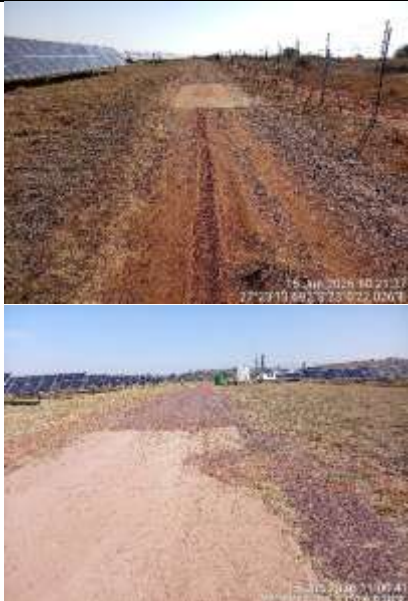
| Image | Example and Action | Timeframe to Resolve |
|---|---|---|
| | <p>Siltation of storm water channel across the road. Storm water infrastructure must be cleared of silt regularly to limit surface water contamination and increase safe driving conditions on site.</p> | |

| Impact Management Actions | Compliance Results | |
|---|---|---|
| The entire area of the site (19.99 hectare area) should be monitored to ensure that erosion onsite and specifically between the lines of solar panels is not eroded. Water runoff from the panels during heavy rain events may cause sheet flow and localised channel flow, and may cause erosion. Low level gabion structures and natural ground colour sand bags should be placed in areas where stormwater runoff is fast flowing, | ✓/X | Silt collected in the road stormwater channels across the internal roads. |

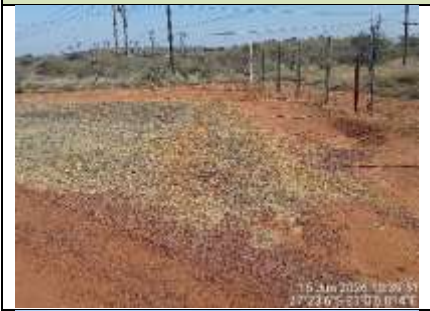
| Image | Example and Action | Timeframe to Resolve |
|---|---|---|
| | <p>Additional areas are being cleared by security and maintenance personnel via repeated foot traffic. If possible personnel should avoid continuously following the same route. Giving vegetation time to recover</p> | |

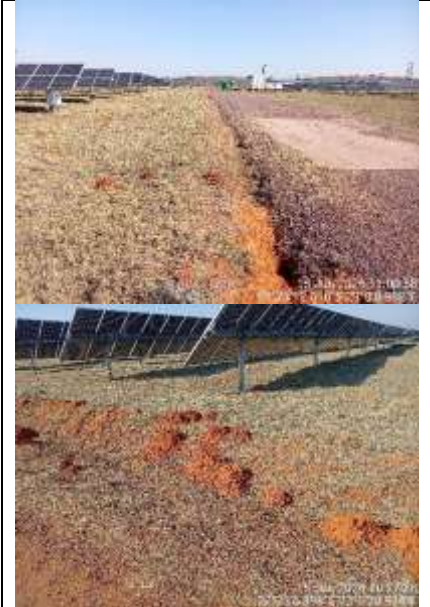
| Image | Example and Action | Timeframe to Resolve |
|---|---|---|
| | <p>The shape of storm channels must be maintained and adequately shaped to ensure that channels don't become wider and eroded further or undercut.</p> <p>Where fauna such as groundhogs are responsible for channel disruption care must be taken to not harm the animals during maintenance.</p> | |

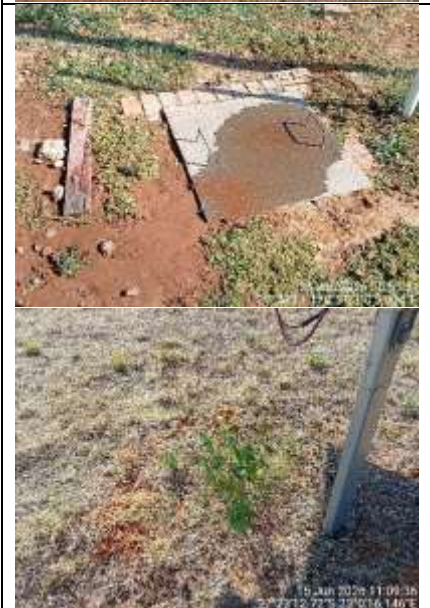
| Image | Example and Action | Timeframe to Resolve |
|---|---|---|
| | <p>All AIS must be removed regularly as per the AIS management plan available for Adams from SOLA.</p> | |

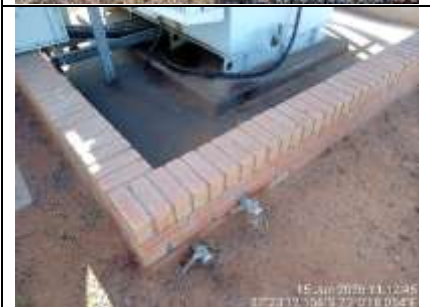
| Image | Example and Action | Timeframe to Resolve |
|---|---|---|
| | <p>The transformer on site's bund dry but stained with HCS leaking from a section of the transformer. During the documentation audit, no safe disposal certificate of the previously disposed waste water was made available. Safe disposal certificates of all waste disposal must be obtained and kept for record and proof of adequate disposal.</p> | |

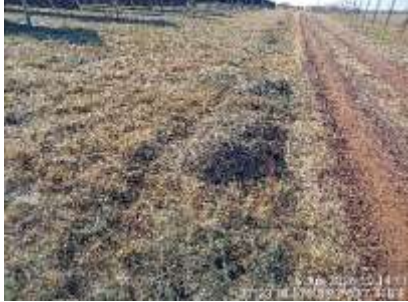
| Image | Example and Action | Timeframe to Resolve |
|---|---|---|
| | <p>Plant material, looking like AIS that was removed has dried in the small stockpiles (Heaps). As it is currently burning season it is recommended that the remnant plant material is removed and adequately disposed of with record thereof being kept.</p> | |

As a safety precaution as well as enforcing adequate maintenance on site, the dried cut vegetation, likely AIS should immediately be removed as it presents a fire hazard as it is currently burning season.

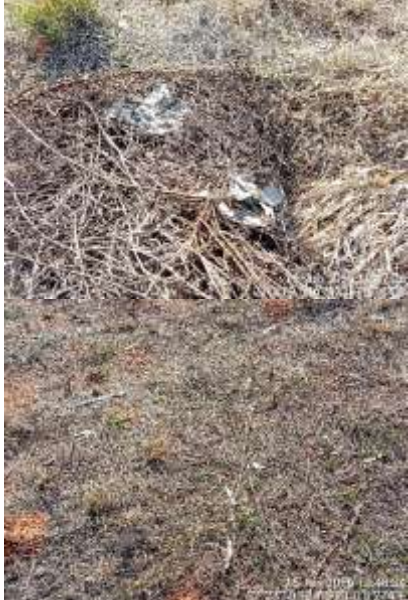
| Image | Example and Action | Timeframe to Resolve |
|---|---|---|
| | <p>Litter from solar panel packaging remains where the panels were previously stored prior to being stored in a container. Litter must be contained and adequately disposed of.</p> | |

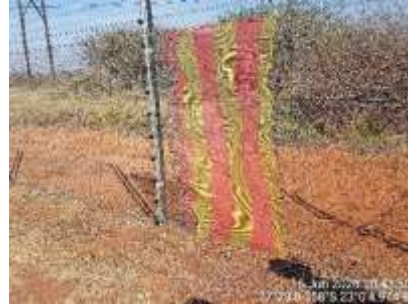
Fence where break in was reported is temporarily repaired.

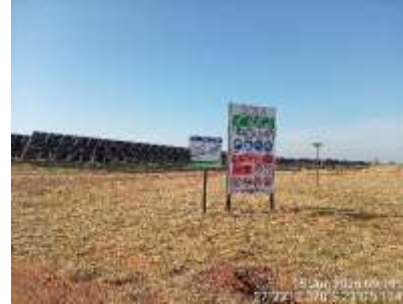
Safety site signage.

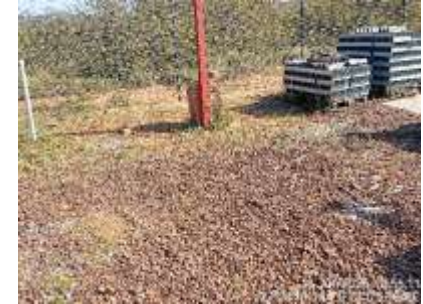
Litter adjacent to the site office from solar panel wrapping.

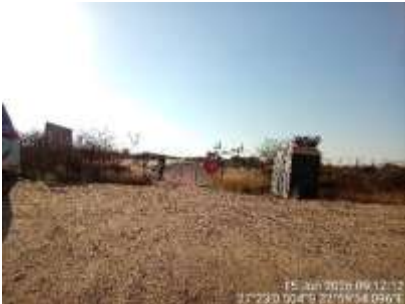
Access control to the site.

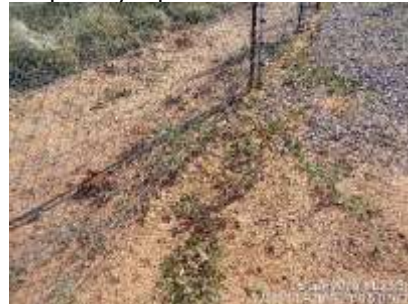
AIS adjacent to site fence.

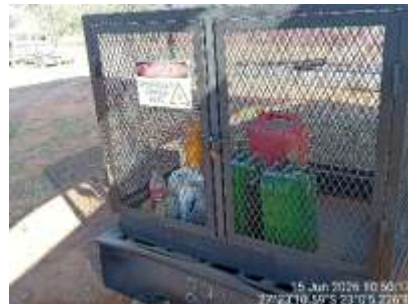
HCS cage on site.

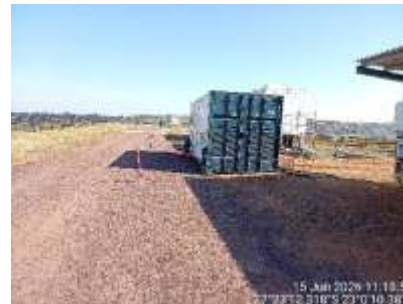
Temporary transformer in container with internalised bund.

| Impact Management Actions | Compliance Results | |
|---|---|---|
| APS will be responsible for rehabilitating any damaged caused to the environment due to any event or incident occurring on site. | ✓ | The transformer is currently being repaired with a temporary mobile transformer currently on site. |
